## ALTARPIECE OF THE CHURCH OF ST. MARTIN ISAR (BURGOS)

## ALTARPIECE OF THE CHURCH OF ST. MARTIN

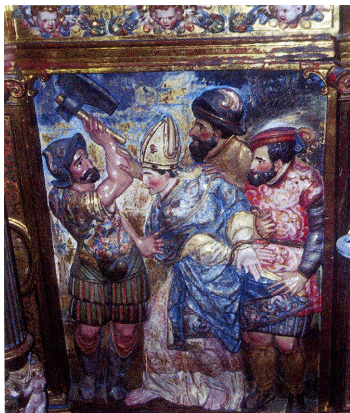
Relief of the martyrdom of St. Martin

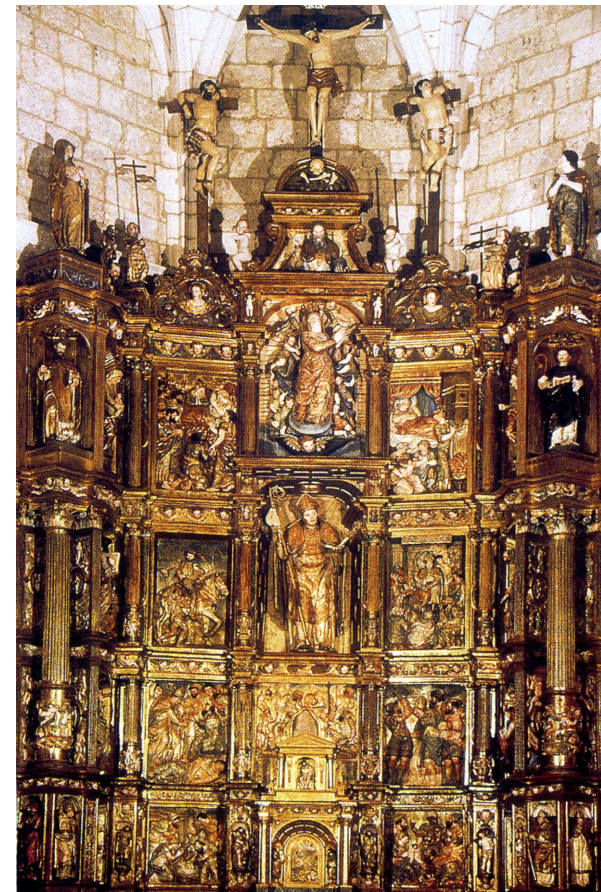
The San Martín Parish Church, built in the twelfth century, was much restored in the fourteenth century: among the most important actions should be noted the replacement of the Gothic Romanesque apse and the covering of the central nave vaults. In 1742 master Francisco de Bazteguita lifted the steeple tower replacing.

The altarpiece was built between 1558-1564 by Domingo of Amberes, finally the oak was gilded and painted in 1595 at the hands of Pedro Ruiz de Camargo and Juan de Cea of Burgos. Therefore it is a work framed in full revival, which betrays a monumental Romanism, a term coined by fans of the style of Michelangelo in Rome. In fact, Domingo of Amberes altarpieces have already lost the profusion of decorative

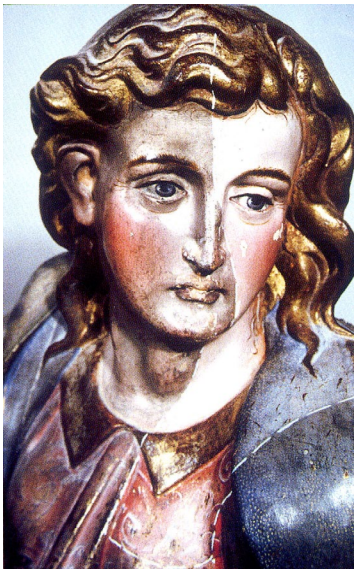
*Detail cleaning, sculpture of St. John the Evangelist*

As for the polychrome, we proceeded to make a sense of color after cleaning, eliminating unnecessary repainting. Finally, in addition to protecting and consolidating the paintings, was completed with the assembly of the altarpiece.

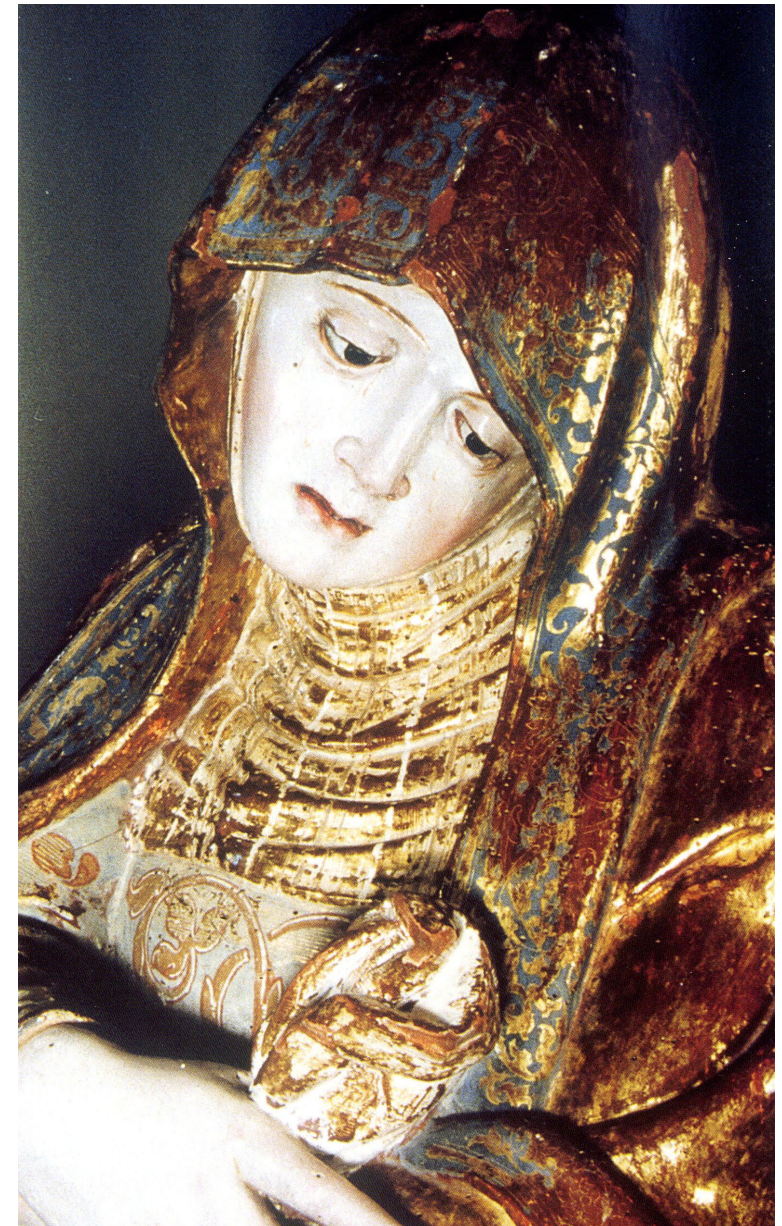
The cause of most problems of the altarpiece was capillary moisture from the stone bench and walls of the headwall. These conditions led to an attack by white rot fungi and wood boring insects, leading to loss of volume and physical consistency of the support timber.
